# mp5 internal volumes

State: September 2013

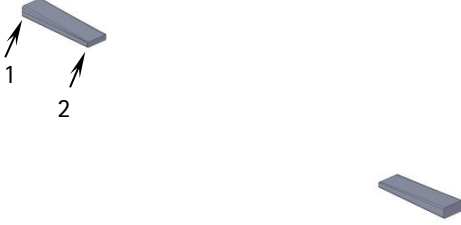
1.95 – 5.4 $\mu\text{l}$ Differences caused by variations of O-ring seal stiffness.
entrance of pump chamber

0.65 $\mu\text{l}$
inlet & outlet tubing clip
